U.S. Virgin Islands Coastal Vulnerability Index

February 2023

This report presents a first assessment of coastal vulnerability in the U.S. Virgin Islands, following and adapting the method developed by the USGS in the late 1990s. It presents a detailed inventory of coastal geomorphic types and coastal infrastructure, estimates of the flooding risk due to sea-level rise and storm surge, and of the wave climate around the islands. The report also presents estimates of rates of accretion and erosion for select beaches. The final estimate of coastal vulnerability shows that St. Croix is the most vulnerable of all islands because of the preponderance of long stretches of sandy beaches and higher wave climate. We also find that on all islands, and on St. Thomas and St. John specifically, economically important beaches, some of them near hotels, are highly vulnerable. Finally, we find that many beaches and wetlands are moderately to highly vulnerable to coastal hazards, especially to sea-level rise and storm surge. Based on these findings, we provide a series of recommendations to better understand these vulnerabilities and develop adaptation and mitigation activities to protect beaches

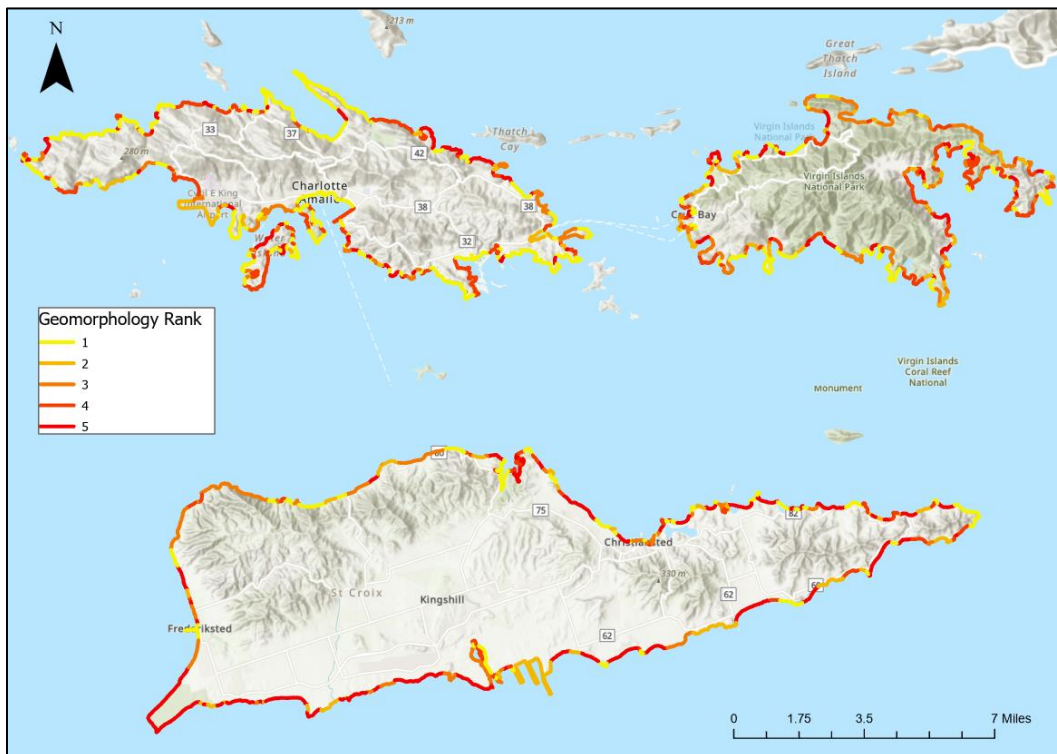
Figure 1: Shoreline type distribution in the USVI.

We find that most of the shoreline of the USVI is rocky or made of consolidated material, from high cliffs to wave cut platforms. The second most common shoreline type is sandy beaches, followed by mangroves and coastal vegetation, armoring and gravel beaches (Figure 3). However, the relative distribution of shoreline types varies between islands. For example, while St. Croix has 38% of its coastline classified as rocky; St. Thomas and St. John have more than half of their coastline classified as such (61% and 57%, respectively). On the other hand, St. Croix has 30% of its shoreline made of sand, while St. Thomas and St. John sandy beaches are present on 10% and 13% of their coast, respectively. Also, while St. John only has 2% of its coastline armored, St. Thomas and St. Croix have armoring on more than 10% of their coastline (12% and 13%, respectively). It is noteworthy that the total length of beaches and the total length armoring on St. Thomas are nearly the same. Even St. Croix has “only” three times as much beaches as armoring, from a cumulative length point of view. In other words, St. Thomas coastal environment is quite developed. St. Croix coast is also developed, but has more natural coastlines. St. John is the least developed of the islands. The three islands have unique geomorphologies, and thus unique responses to hazards.

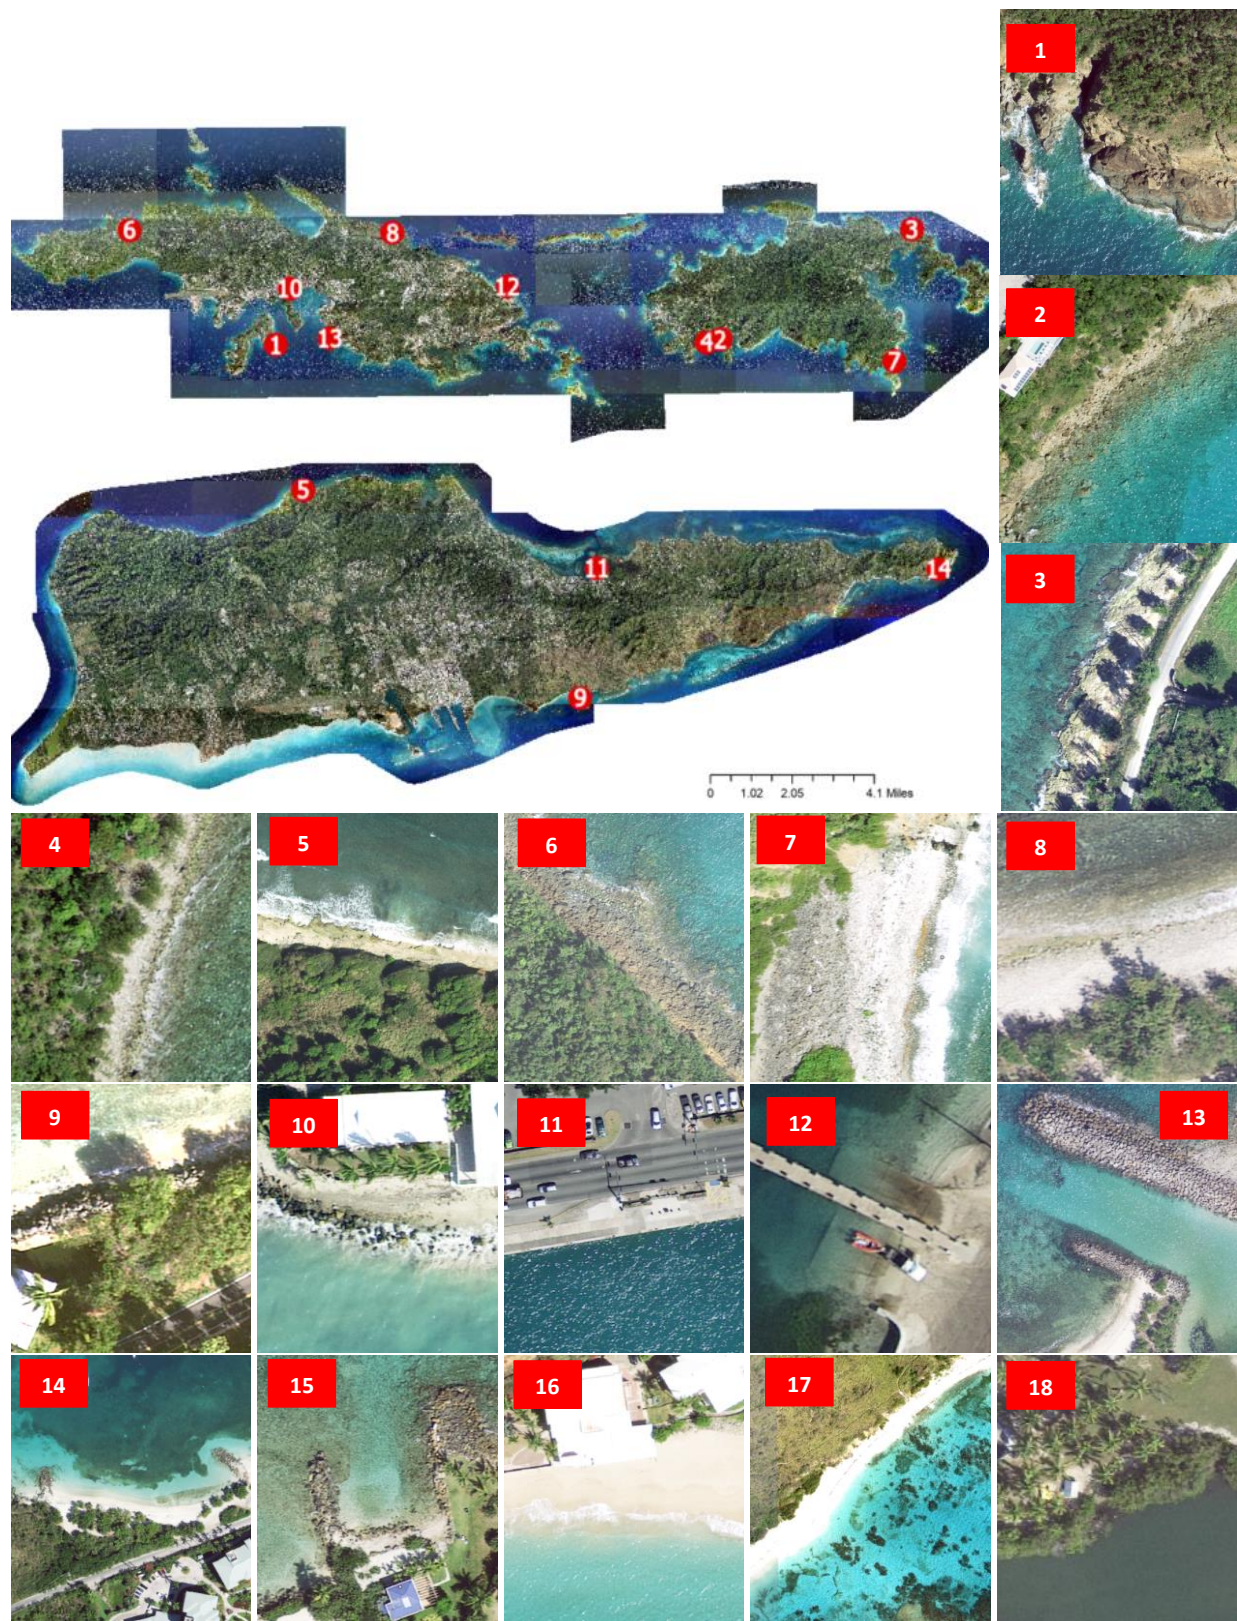
Figure 2: Aerial imagery of different shoreline types. Shot 1: High rocky cliff (rank 1); shot 2: medium erodible cliff (rank 2); shots 3 to 6: Low erodible cliff (rank 3); shot 7 and 8: gravel beach (rank 4); shot 9 and 10: riprap revetment (rank 3 or 4); shot 11: bulkhead or seawall (rank 1); shot 12: pier and boat ramp (rank 1); shot 13: jetty built with riprap (rank 2 to 3); shots 14 and 15: groin built with riprap (rank 2 to 3); shots 16 and 17: sandy beach (rank 5); shot 18: vegetated shoreline (rank 5).

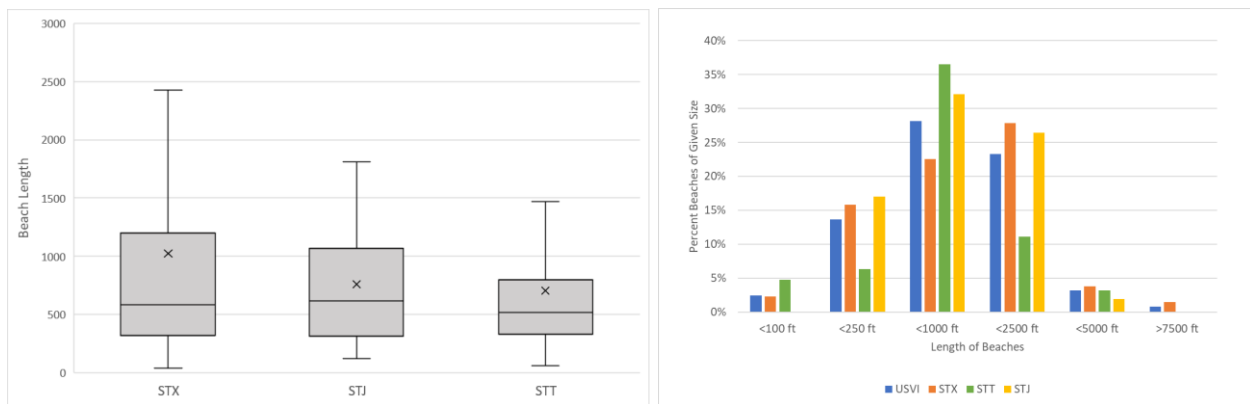
Figure 4: Distribution of sandy beach length in the USVI.

In general, St Croix has many long stretches of beaches, with some small, isolated pocket beaches. St. Thomas on the other hand has many small pocket beaches with a few long beaches. St. John has a mixture of both, but does not have beaches as long as St. Croix’. These differences can also be found in the number of bays that each isle has: St. Croix has 53 bays, whereas St. Thomas has 83 and St. John 70.

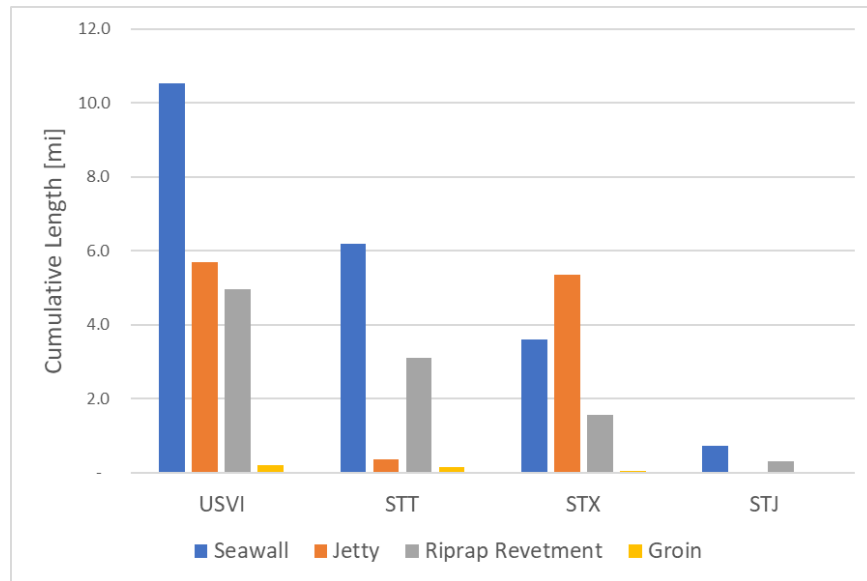
Figure 5: Distribution of large coastal infrastructure around the USVI

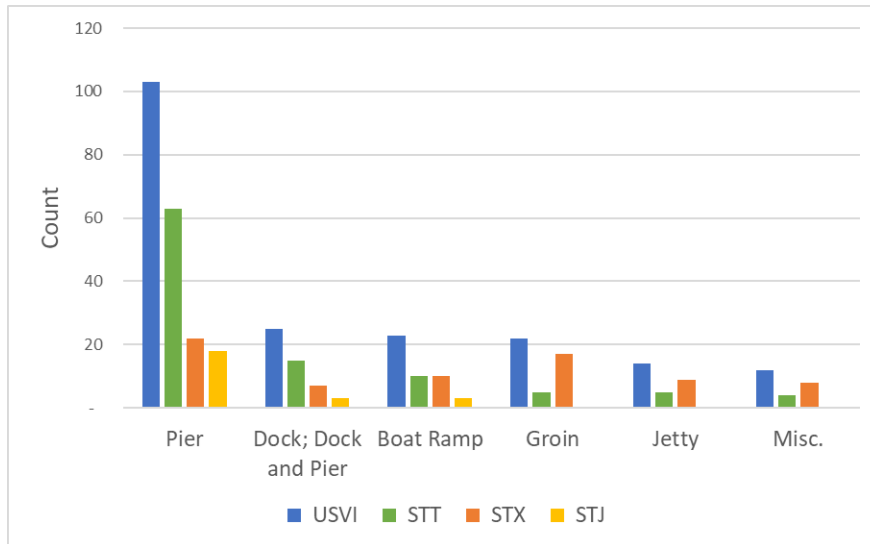
Figure 6: Distribution of navigation coastal structures in the USVI.

Even though there is a relatively small amount of the coastline that is hardened for protection against erosion or inundation, most of the coastal infrastructure seems to have been built to facilitate transportation (Figure 6). Most of the seawalls mentioned above were built to protect roads, and most of the jetties were built to facilitate commercial marine transportation. In addition, there are a fair number of piers (outside of marinas), used by small boats and other large vessels. St. Thomas has the largest number of piers, followed by St. Croix and St. John, to a smaller extent. Next are docks, with or without a pier, where once again St. Thomas surpasses the other two islands. Surprisingly, St. Thomas and St. Croix have the same amount of boat ramps, while St. John only has a few. The next two categories are groins and jetties, which are located mostly on St. Croix, as discussed above. In addition to these structures, the USVI has a total of 13 marinas: 9 on St. Thomas, and 4 on St. Croix. Most of these marinas are located near mangroves, seawalls, and beaches.

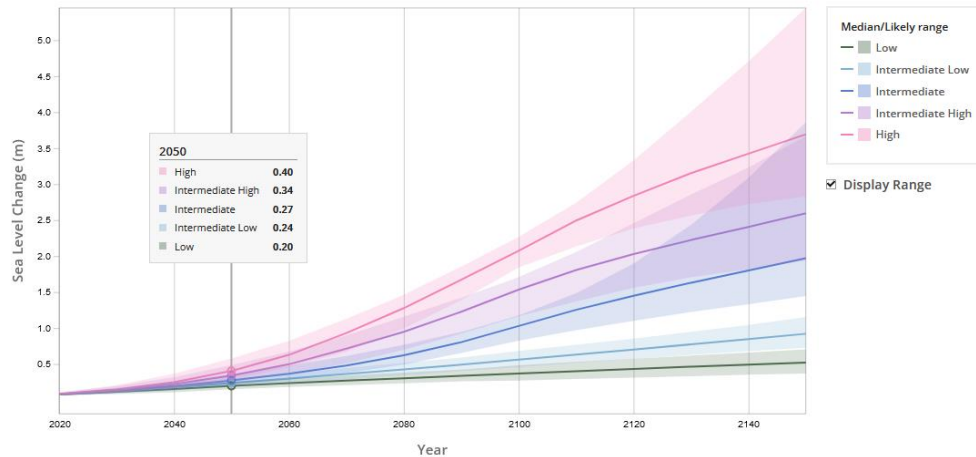
Figure 11: Projections of sea-level rise values on St. Croix. Screenshot from NASA online tool²⁶

Projections to 2050 indicate that sea level is likely to continue to rise by similar values in the USVI (Figure 11). Sea level is projected to rise by 0.22 m in 2050, or 0.72 ft, above 2020 levels. This assumes a SSP1 2.6 scenario, or a projected increase in temperature of 1.8°C by 2100²⁶. The Intermediate scenario in Sweet et al.²⁴ predicts 0.19 m (0.62 ft) by 2050 from 2020, and the Intermediate High predicts 0.26 m (0.85 ft) by 2050 from 2020. Regardless of the projection tool and method, it is predicted that local sea levels are going to rise by 0.7-0.9 ft by 2050 from 2020 levels.

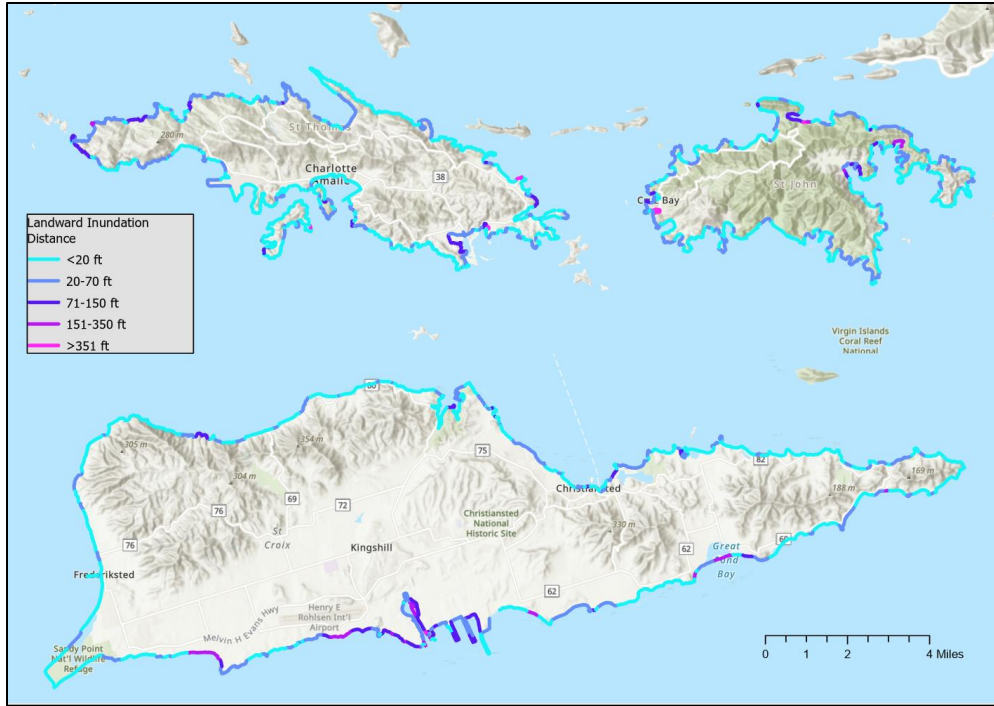
Figure 12: Landward inundation distances expected by tidal flooding assuming a 1 ft sea-level increase

However, these results do not compare well against sea-level rise modeling results (Figure 12) as there are limited regions that will experience large tidal inundation by 2050. More importantly, these results do not compare well against storm surge modeling results published by NOAA⁸ (Figure 16). The reason for this discrepancy is that storm surge inundation is not a static process where a simple bathtub approach provides an answer for which region is more at risk than another. Storm surge buildup is a complex function of storm direction and characteristics, as well as nearshore and shoreline bathymetry. In other words, it is a highly nonlinear process, which a simple coastal slope approximation does not capture.

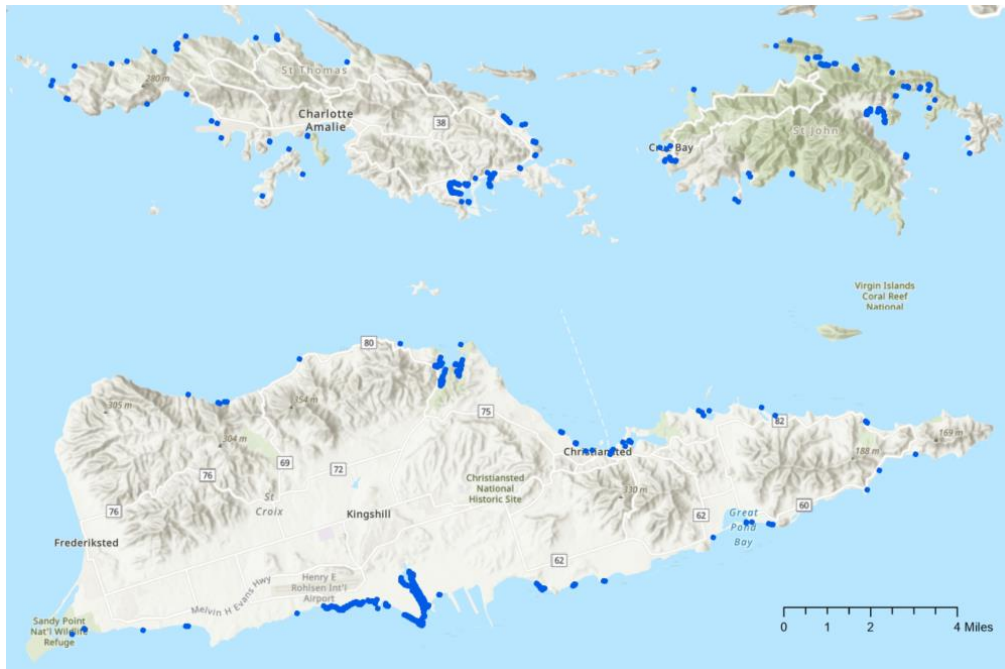
Figure 13: Regions experiencing tidal flooding 100 ft from the shoreline assuming a 1 ft sea-level increase.

As illustrated in Figure 13, we find that the most vulnerable areas to sea level rise inundation are Mangrove Lagoon and Smith Bay on St. Thomas, which are home to extensive wetlands. On St. John, Coral Bay and most of the northern coast of the island are also vulnerable to tidal flooding. This is due to the fact that many of the longest beaches of St. John are on the northern coast. On St. Croix, the central southern coast, home to mangroves and beaches, and Salt River Bay, a wetland, are most at risk. In other words, aside from the loss of footprint for many beaches and coastal areas, the most extreme impacts of sea level rise will be felt by mangroves and some beaches. Given the fact that roads and other infrastructure are built landward of these important habitats, it is likely that the territory will experience an irreversible loss of wetlands and of beaches, to a lesser extent. It is also likely that impacts from coastal hazards on the infrastructure buffered by these habitats will be more pronounced.

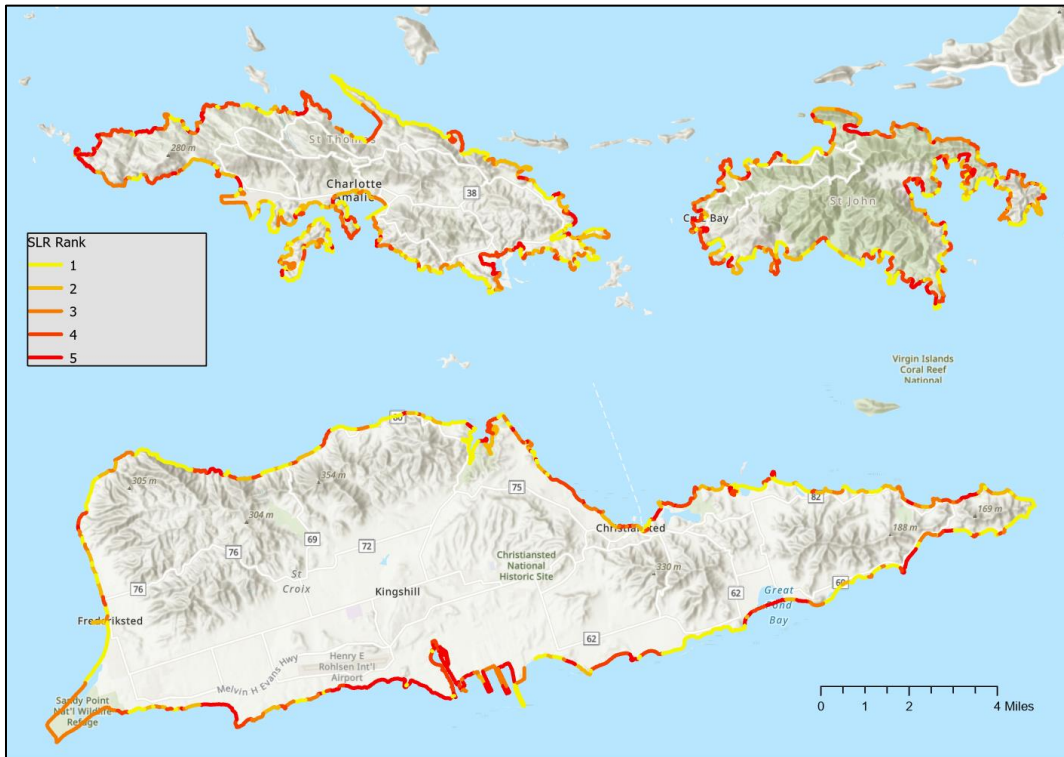
Figure 14: Sea-level rise ranking

less inundated will receive a lower rank, and regions that are more inundated will receive a higher rank. Sea-level rise ranking is shown in Figure 14.

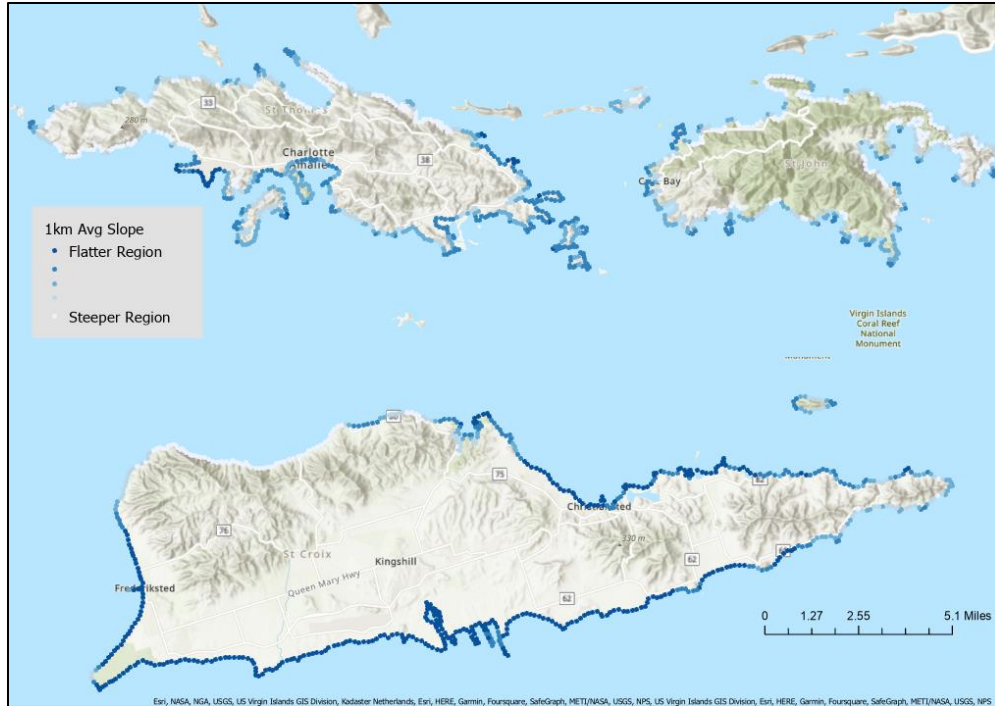
Figure 15: Distribution of coastal slopes (quartile approach) around the USVI.

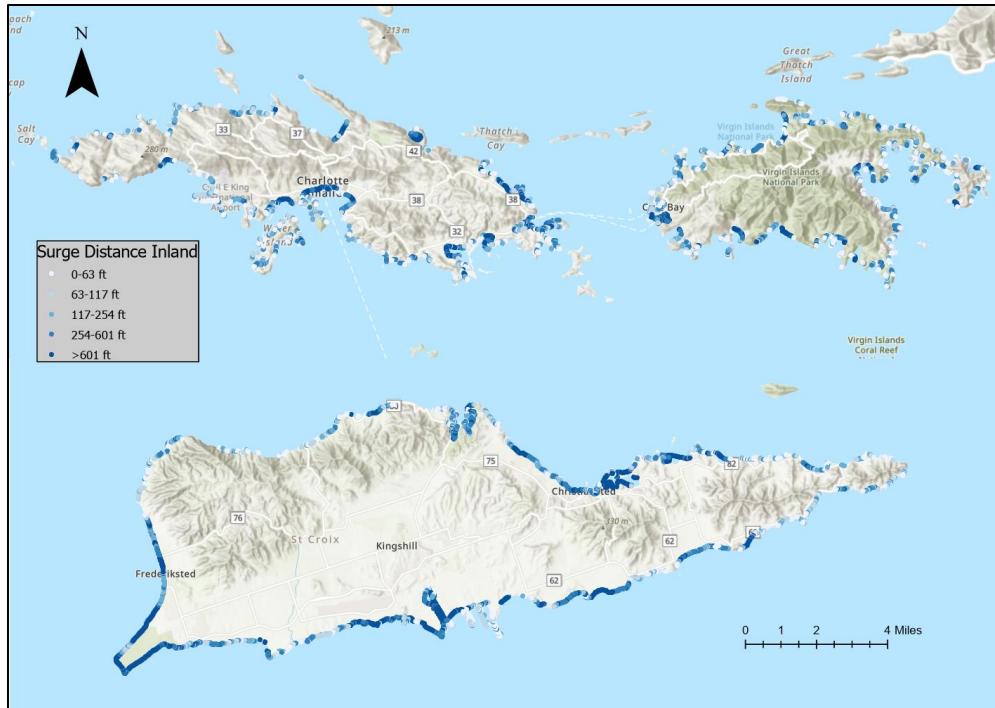
Figure 16: Storm surge inundation distance from the coast as computed by the SLOSH model⁹

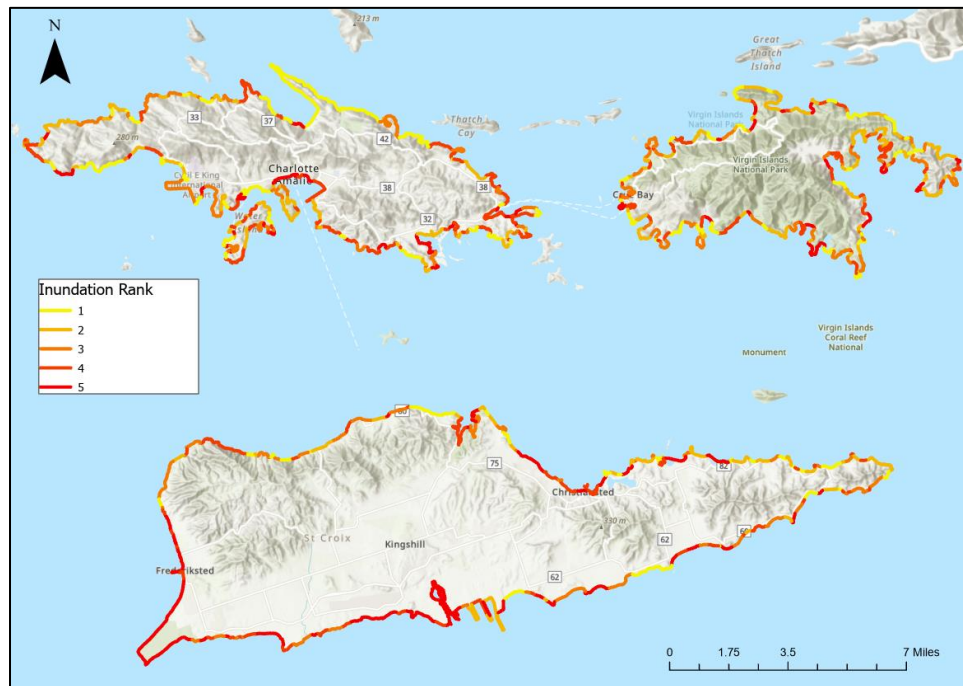
Figure 17: Final coastal inundation/coastal slope rank.

These results show that inundation risk, whether computed from sea-level rise projections or storm surge, is different from the estimate provided by coastal slope. This is likely due to the small footprint of the islands as well as a narrower shelf. As a result, we will not use the coastal slope result in our analysis. Instead, we will replace it by the coastal inundation risk as computed from SLOSH model results (Figure 17).

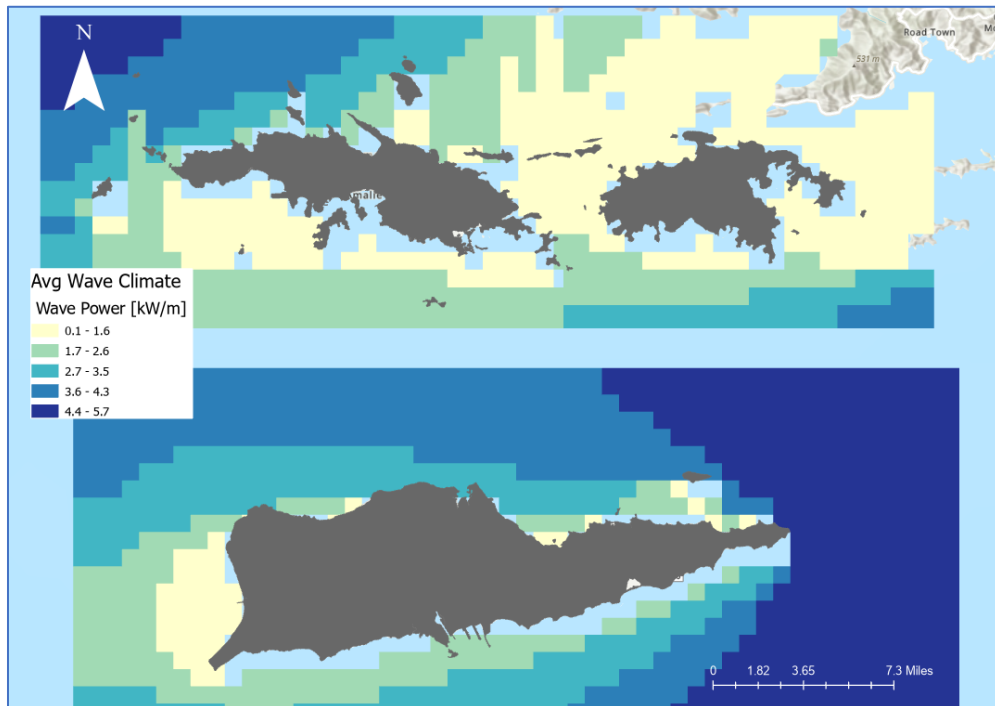
Figure 18: Wave power climate around the USVI

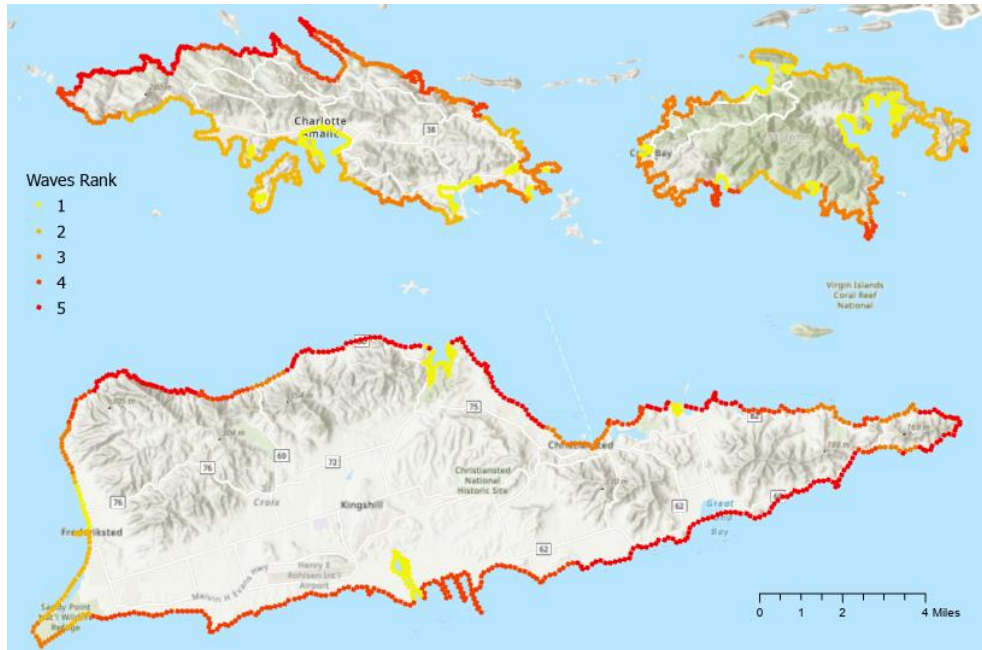
Figure 20: Wave power ranking for the USVI.

around the islands. Figure 20 shows the wave power ranking for the islands, created using the average wave height distribution.

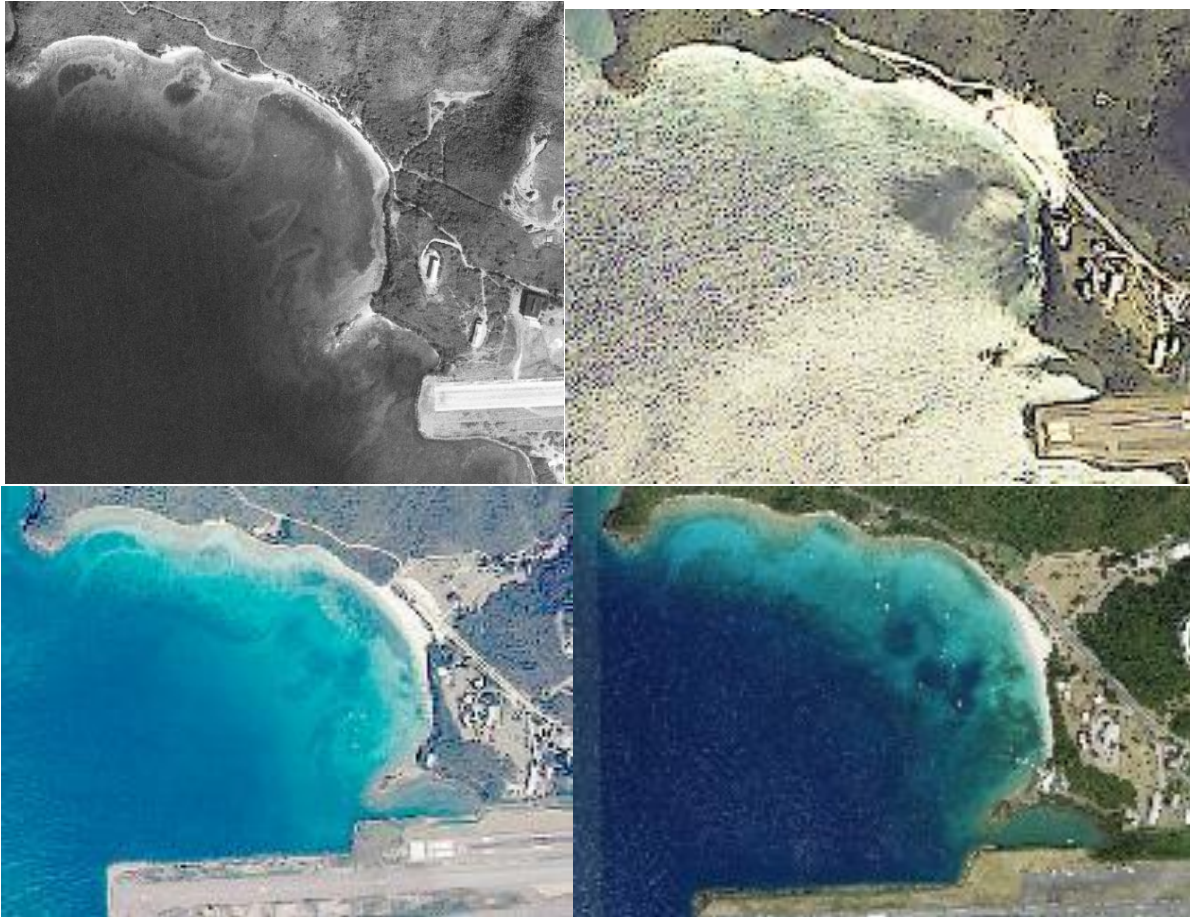
Figure 21: St. Thomas airport and Brewers Bay in 1954 (top left), 1970 (top right), 1980 (bottom left), and 2020 (bottom right).

On St. Thomas, we find that most of the coastal change has been driven by the construction of the airport, roads, and port facilities. Most of the development also occurred on the south side of the island, probably because of its milder wave climate and proximity to Charlotte Amalie. The Cyril E. King airport runway extension occurred in the late 1970s, early 1980s (Figure 21). Brewers Bay seemed to have at that time a sandy beach on its northern side, and a wetland on southern side. The wetland seems to have been damaged by the extension of the runway. However, the new runway seems to now act as a major breakwater for waves, and moderates the wave climate in Brewers Bay as they mostly move from the southeast to the northwest. As a result, sand moved from the west side of the beach to the east.

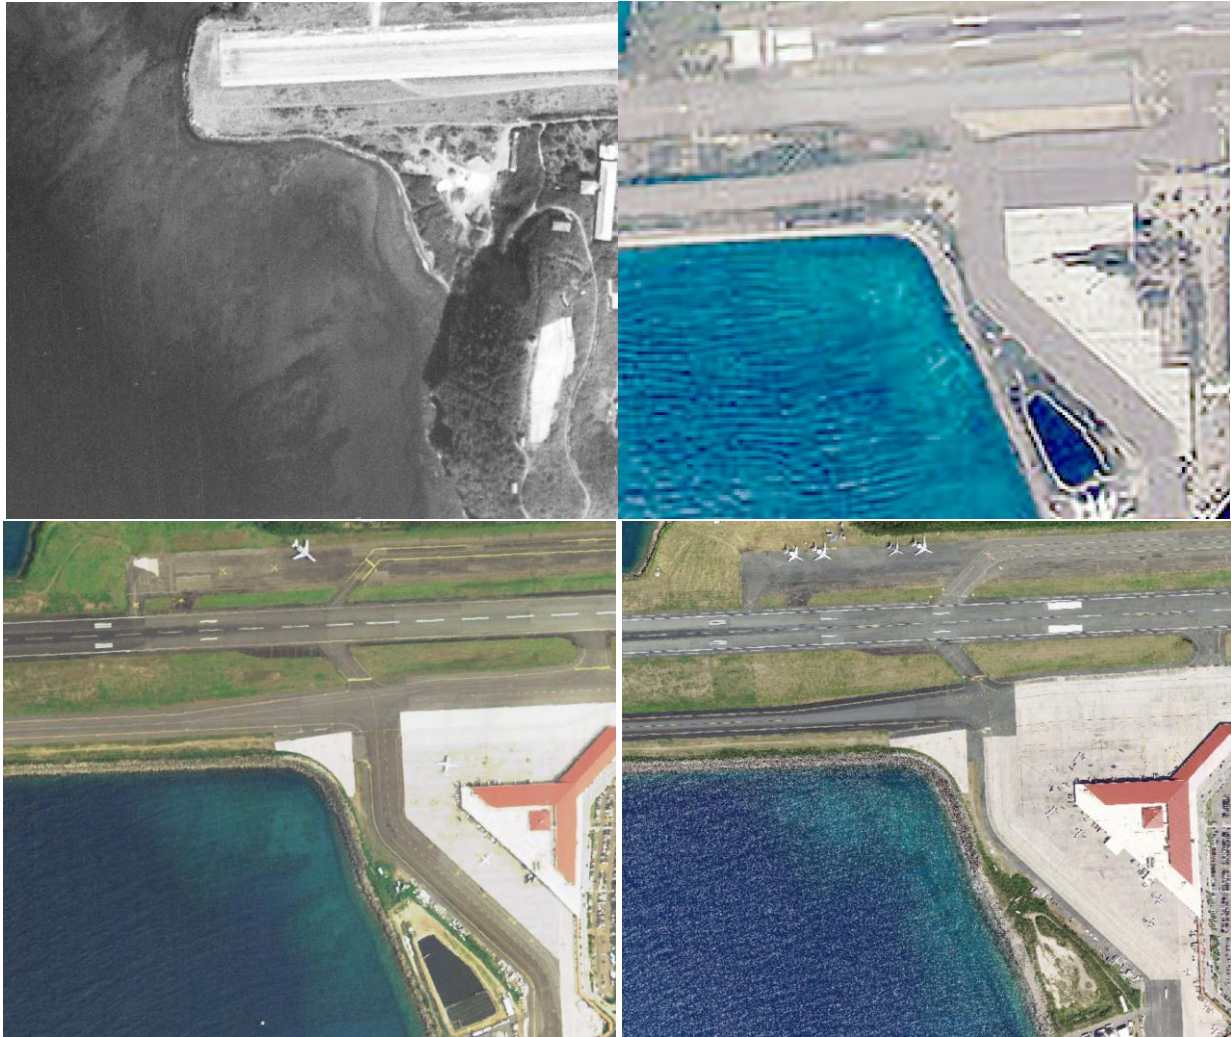
Figure 22: St. Thomas airport, south side of the runway in 1954 (top left), 1980s (top right), 1990s (bottom left), and 2020 (bottom right).

On the other side of the runway, it appears that the land was also filled and leveled to expand the terminal and other facilities (Figure 22). The whole airport and surrounding land has been armored to protect the newly placed fill.

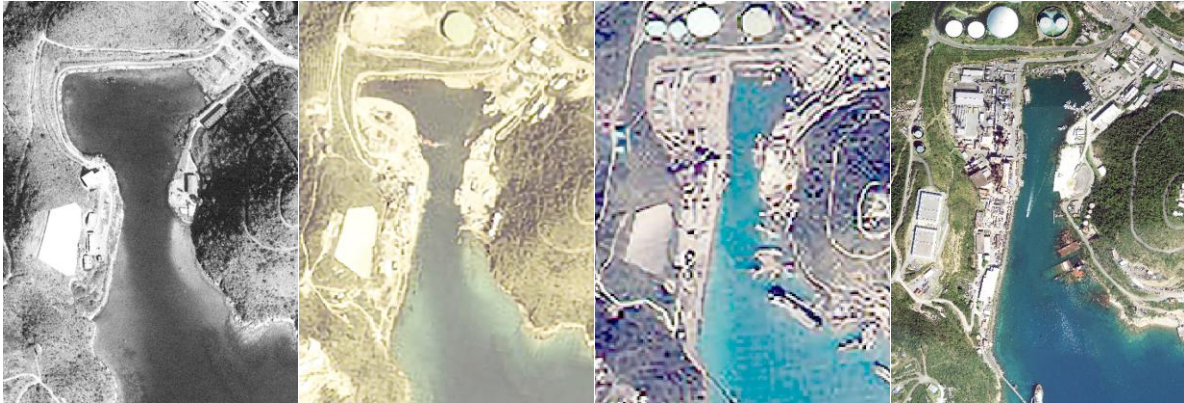
Figure 24: Krum Bay and WAPA power plant construction in (from left to right): 1954, 1970, 1990, and 2010

Krum Bay, where WAPA facilities are located, was filled and armored to accommodate the construction of the power plant in the 1970s (Figure 24). Further construction and armoring of the shoreline continued into the 2010s.

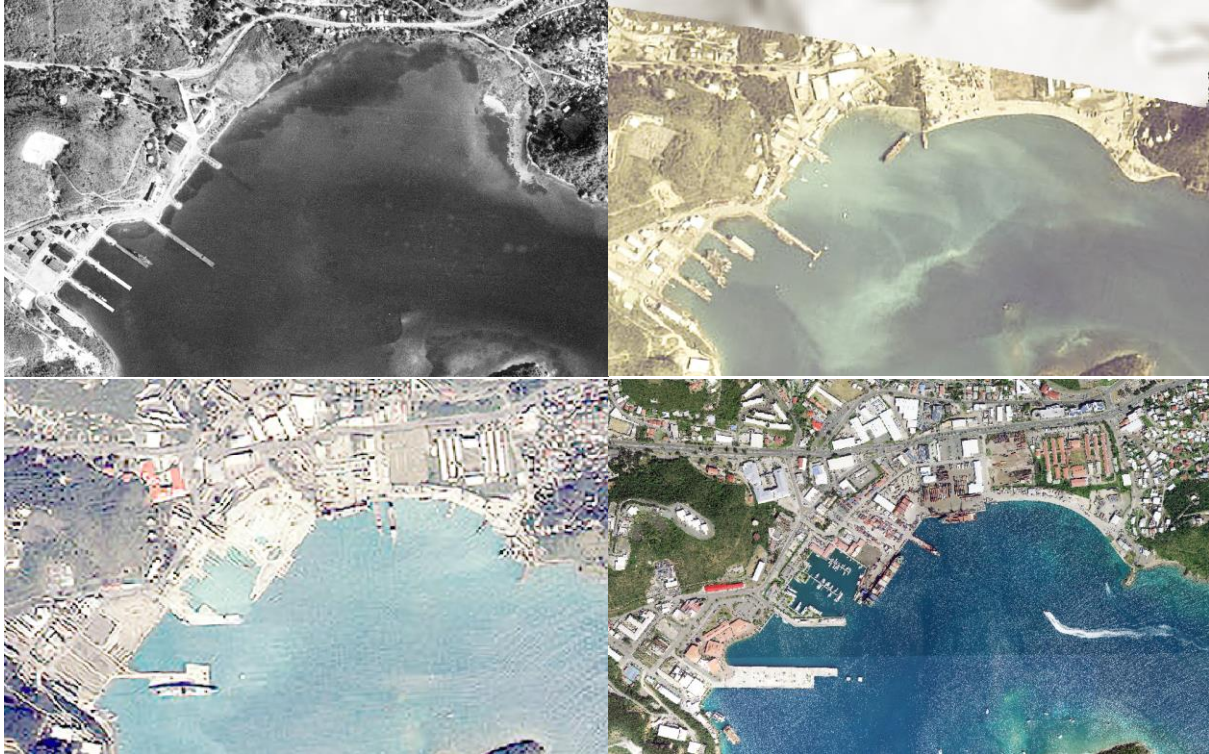
Figure 25: Expansion of the port infrastructure in St. Thomas from 1954 (top left), 1970 (top right), 1980 (bottom left), to 2020 (bottom right).

In Crown Bay and Little Krum Bay, the Port was expanded sometime in the 1960s, on top of what appears to be a vegetated shoreline (Figure 25). Significant filling activities occurred in the 1980s to build the marina and other port facilities, including a cruise ship terminal. The terminal was further expanded on fill in the 1990s, and construction was finalized in the late 1990s/early 2000s.

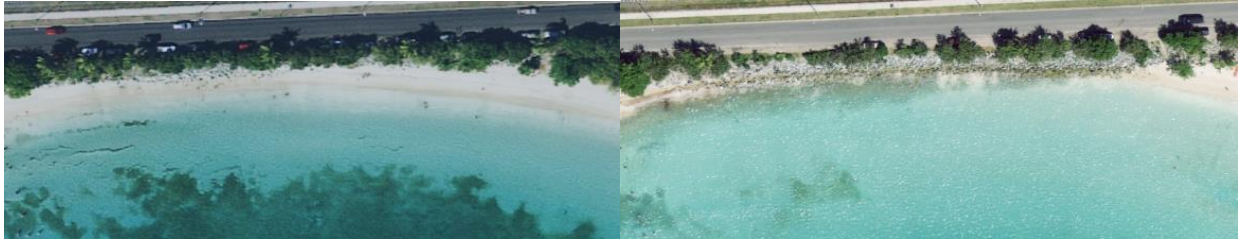
Figure 41: Lindbergh Bay and riprap revetment protecting the road in early 2017, pre-hurricanes, and in 2020.

In addition to these large scale changes, there are many small scale changes caused by structures. On St. Thomas, the construction of the riprap revetment along the airport road altered the cross-shore

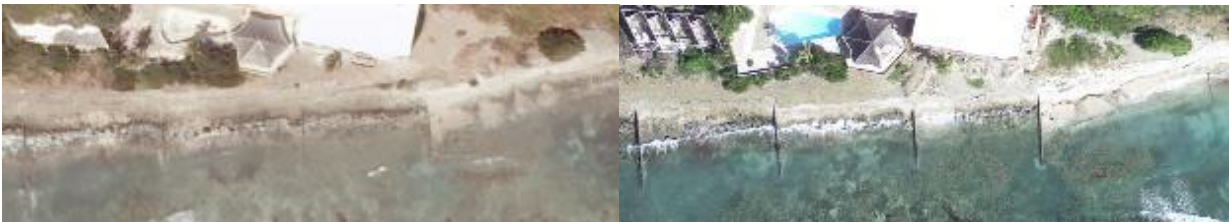
Figure 44: Groins built in front of the Grapetree Bay Hotel and Villas do not seem to stop the (probably cross-shore) movement of sand and coastal erosion (1990 picture on the left, and 2020 on the right).

On the south side of the island, in Grapetree Bay, the construction of groins in front of the Grapetree Bay Hotel and Villas seems to have altered the longshore transport of sediment. Sediment has accumulated east of the first groin (Figure 44), but the beach has eroded further west, especially in regions far from the first groin. In Figure 45, we can observe a drastic reduction of shoreline width, which caused the groins to be fully submerged. Hurricane Maria further accelerated the erosion of the coastline in that region (Figure 45).

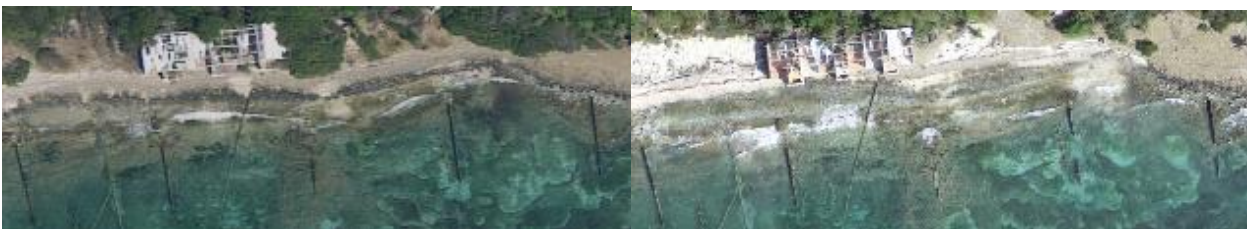
Figure 45: Groins west of the Grapetree Bay Hotel and Villas did not prevent erosion at this location (2010 on the left, 2020 on the right).

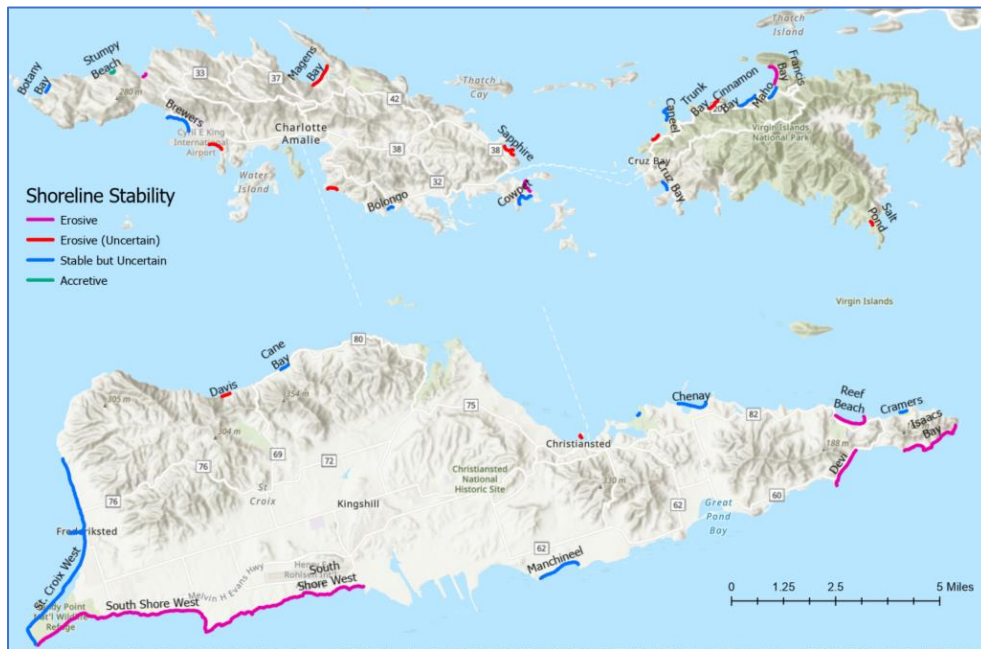
Figure 46: Estimates of stability of select beaches

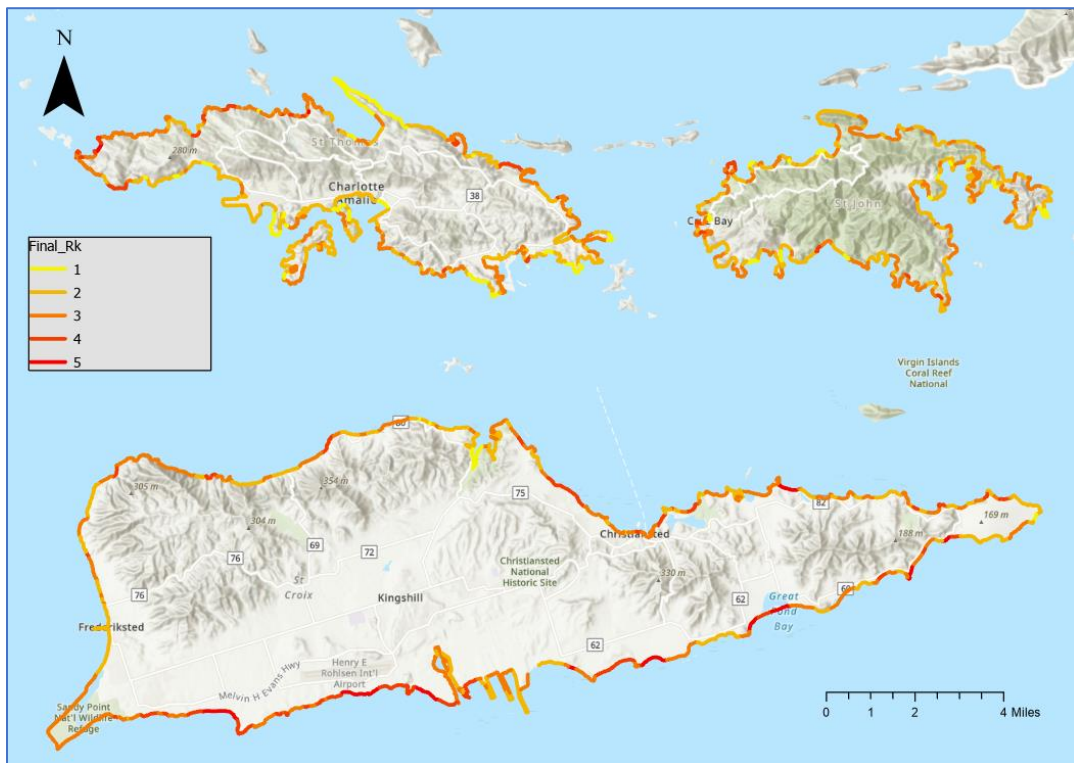
Figure 47: Coastal Vulnerability Indices for various portions of the USVI

Results are presented in Figure 47. We find that the northern and southern shores of St. Croix are the most vulnerable in the territory. Although the region surrounding Christiansted is heavily armored, and somewhat protected by a reef, it is still susceptible to tidal and storm surge flooding. East of Christiansted, many beaches are vulnerable to coastal hazards, as well as most of the beaches on the north and south side of the island. Limetree, which is heavily armored, is less vulnerable. However, the region downstream of Limetree, especially near the racetrack, is quite vulnerable. Powerful waves, sea-level rise and the abundance of beaches and erodible bluffs, and storm surge to a lesser extent, are the key drivers of the vulnerability of St. Croix.

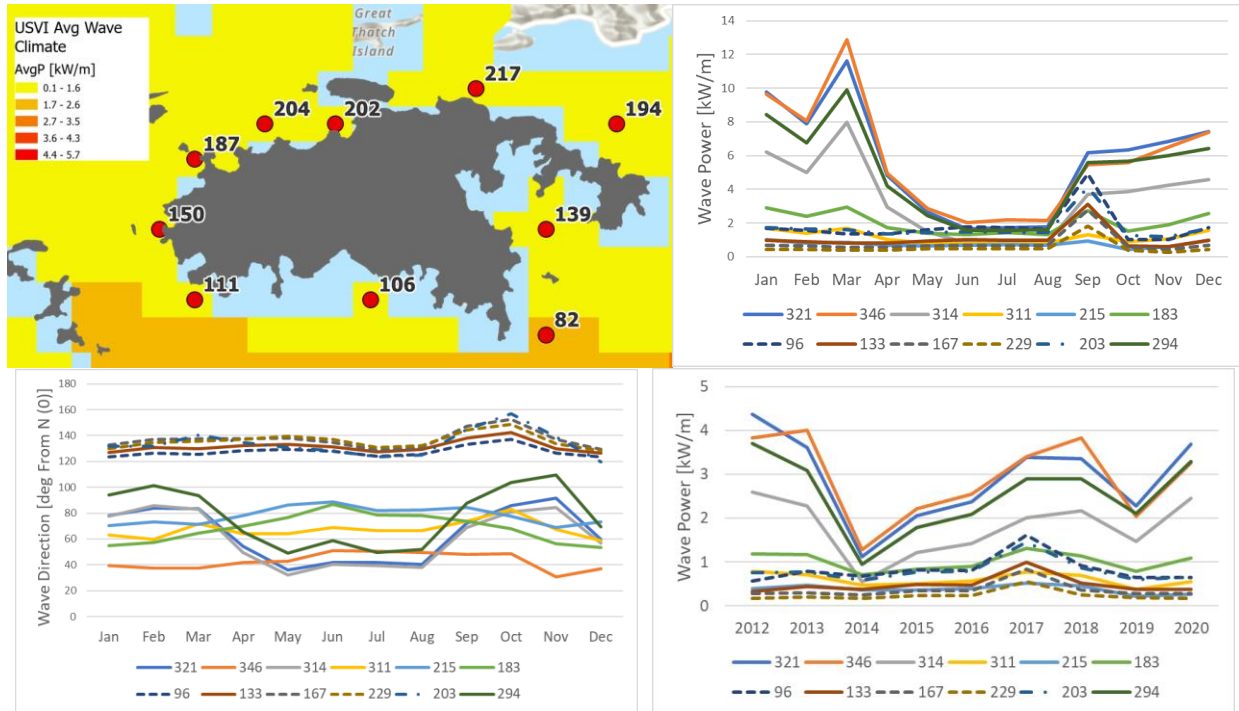
Figure B1: Wave climate around St. John and monthly averaged time series of wave power (upper right) and wave direction (lower left), and yearly averaged time series of wave power (lower right).

As discussed above, the eastern coast of St. John is sheltered by the BVI, which moderates waves coming from the east (points 194 and 217, Figure B1). The southeast coast of St. John experiences a more intense climate (Point 82), where waves come predominantly from the southeast. However, as they propagate closer to the island and water depth decreases, wave power decreases to levels like what is observed on the northern east coast (points 111, 106 and 139 have similar values as points 194, 217).

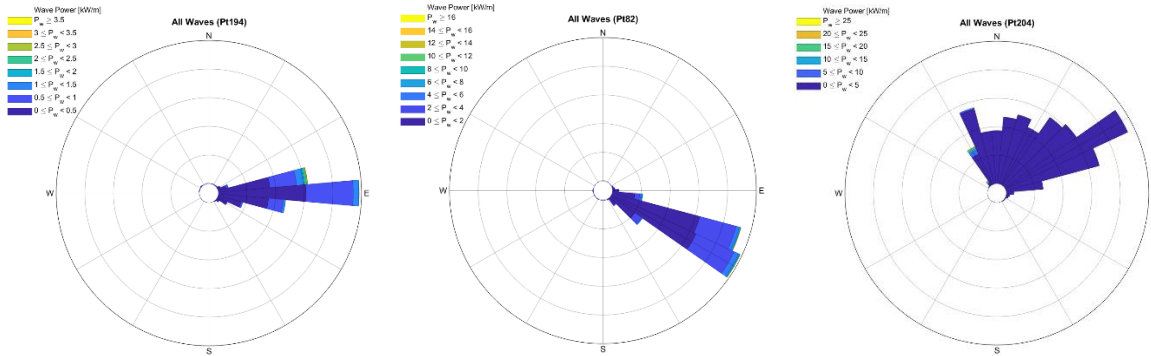
Figure B2: Wave rose for discrete points around St. John: Northeast (Pt. 194), Southeast (Pt. 82), and Northeast (Pt. 204).

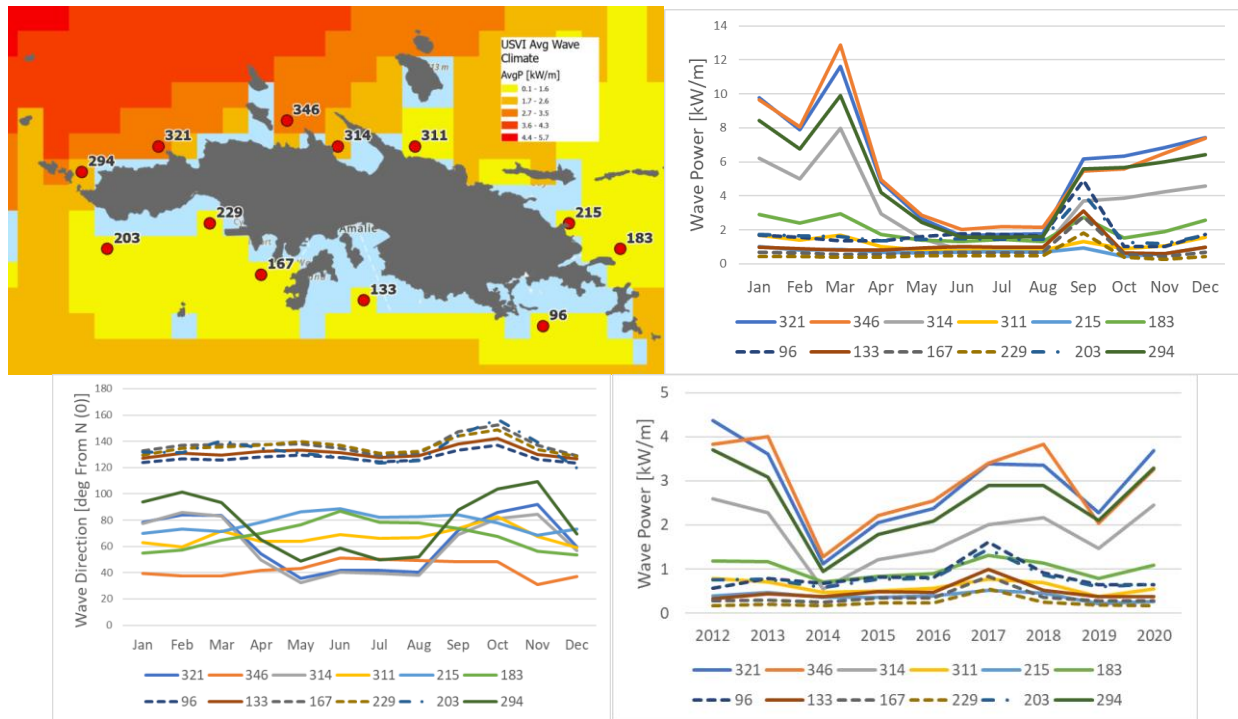
Figure B4: Wave climate around St. Thomas and monthly averaged time series of wave power (upper right) and wave direction (lower left), and yearly averaged time series of wave power (lower right).
