U.S. Virgin Islands Coastal Vulnerability Index

February 2023

This report presents a first assessment of coastal vulnerability in the U.S. Virgin Islands, following and adapting the method developed by the USGS in the late 1990s. It presents a detailed inventory of coastal geomorphic types and coastal infrastructure, estimates of the flooding risk due to sea-level rise and storm surge, and of the wave climate around the islands. The report also presents estimates of rates of accretion and erosion for select beaches. The final estimate of coastal vulnerability shows that St. Croix is the most vulnerable of all islands because of the preponderance of long stretches of sandy beaches and higher wave climate. We also find that on all islands, and on St. Thomas and St. John specifically, economically important beaches, some of them near hotels, are highly vulnerable. Finally, we find that many beaches and wetlands are moderately to highly vulnerable to coastal hazards, especially to sea-level rise and storm surge. Based on these findings, we provide a series of recommendations to better understand these vulnerabilities and develop adaptation and mitigation activities to protect beaches

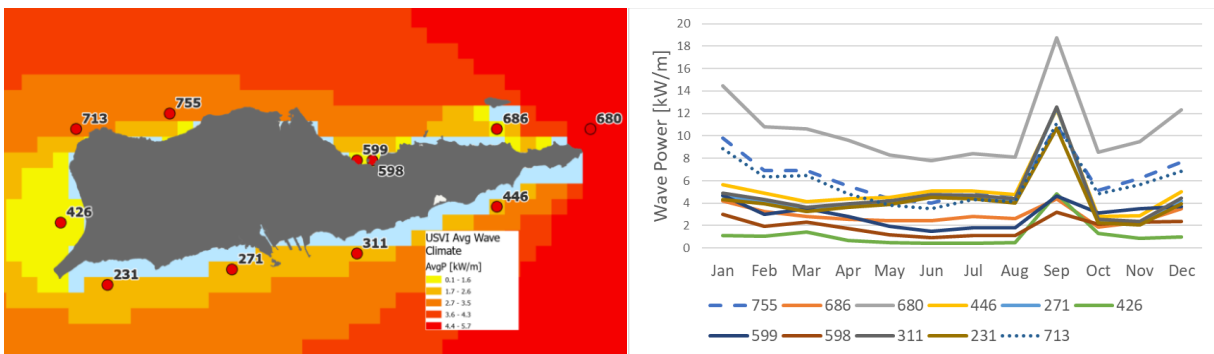
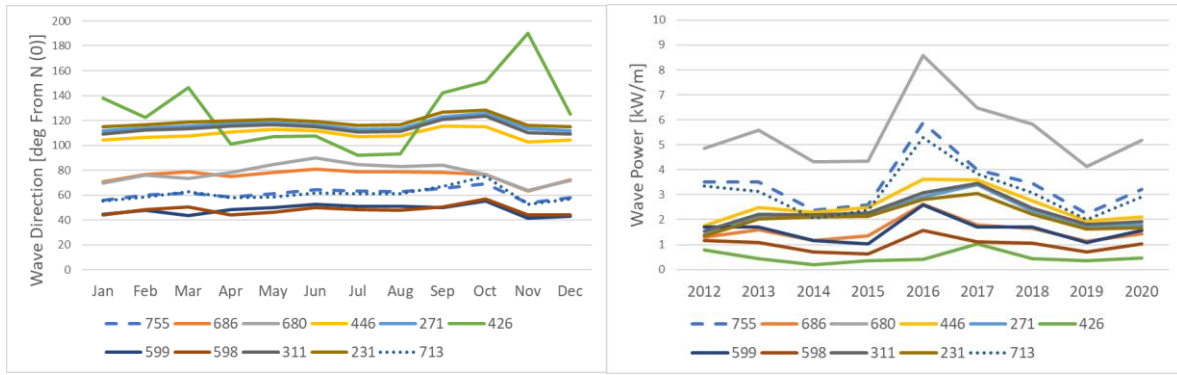
Figure B7: Wave climate around St. Croix and monthly averaged time series of wave power (upper right) and wave direction (lower left), and yearly averaged time series of wave power (lower right).

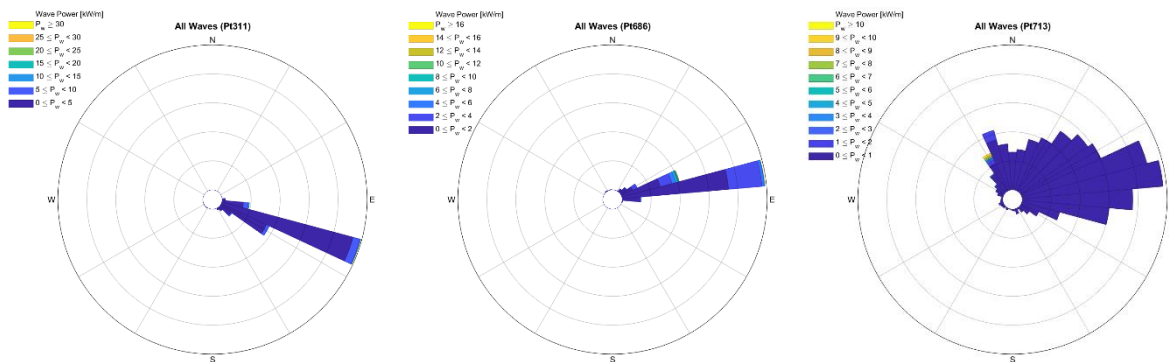
Figure B8: Wave rose for discrete points around St. Croix: Northeast (Pt. 311), Southeast (Pt. 686), and Northeast (Pt. 713)
